Repair of a mirror coating on a large optic for high laser damage applications using ion milling and over-coating methods

Ella S. Field
John C. Bellum
Damon E. Kletecka

Sandia National Laboratories, PO Box 5800, MS 1191, Albuquerque, New Mexico 87185, United States

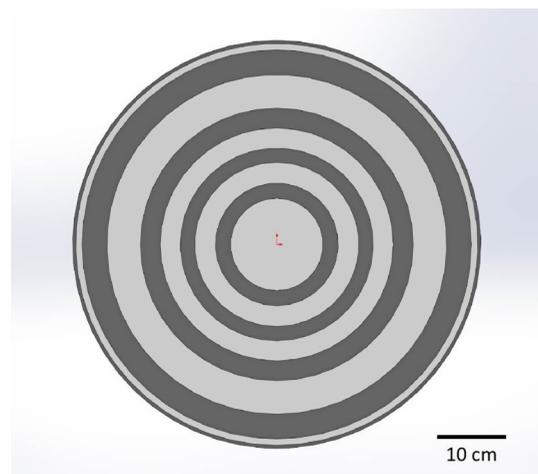
We paused the etch process for the 65-cm diameter BK7 optic when layer 1 appeared (HfO_2). During the pause, we measured the diameter of each ring in the bull's eye pattern, which included layers 1 through 9. A model of the bull's eye pattern, based on the diameter measurements, is shown in Fig. 3, and a plot of the curvature of the etched layers is shown in Fig. 4. A radius of curvature of 32 km, also plotted in Fig. 4, was loosely fitted to the layer thickness data. However, because the substrate etches at a slower rate compared with the coating materials, it was practical to assume that the radius of curvature etched into the substrate would be even greater than 32 km. However, even if the substrate had a radius of curvature of 32 km, this would not have a significant effect on the performance of the mirror.

Fig. 3 Model of the etched coating layers in a bull's eye pattern on the 65-cm diameter substrate just after layer 1 (HfO_2) was exposed. Layer 1 is the central light circle, surrounded by layers 2 through 9. Light colored rings represent HfO_2 and dark colored rings represent SiO_2 . The outermost dark ring is the portion of the BK7 substrate that was masked by the tooling that holds the optic in the coating chamber.

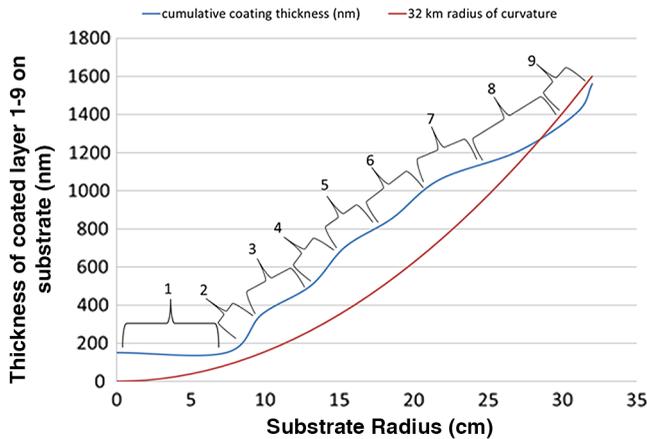
Fig. 4 The thicknesses of the layers present on the substrate with respect to substrate radius just after layer 1 was exposed during the ion milling process of the 65-cm diameter substrate. A radius of curvature of 32 km was loosely fitted to the data to give a conservative approximation of the curvature that would be etched into the substrate. The labeled brackets show the approximate span of each layer, starting with layer 1 and ending with layer 9.

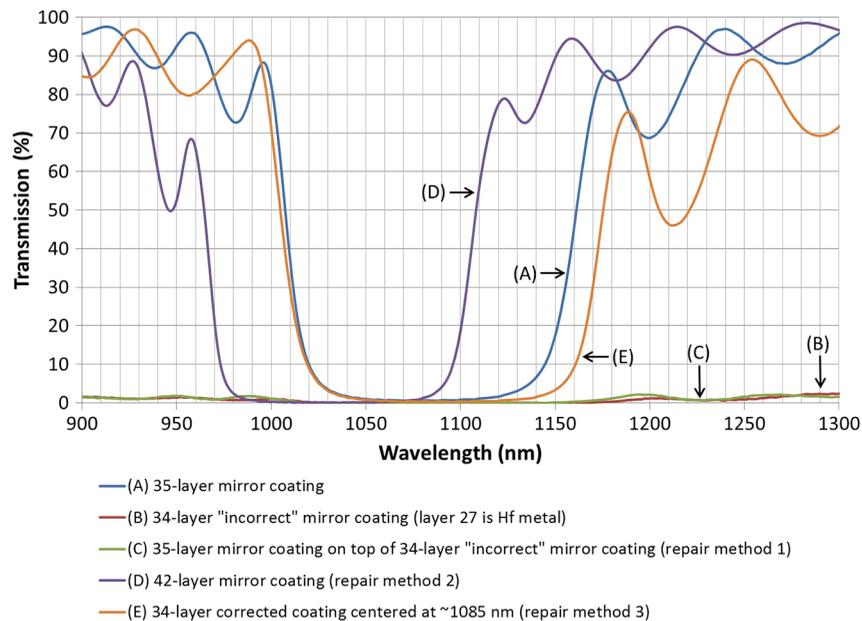
Fig. 5 Spectral scans of the repaired and unrepaired optical coatings, shown in P-pol for 45 deg AOI.

The optical transmission scans shown in Fig. 5 of both the repaired and unrepaired coatings are similar, owing to the broad reflectivity of the Hf metal layer in the incorrect coating. The coatings have low transmission, below 0.04% at both 1054 and 1064 nm. Even so, the low LIDT of the repaired coating indicates that enough light may still be reaching the incorrect Hf metal layer to induce damage. As a consequence of the low LIDT improvement from 1.0 J/cm² to 7.0 J/cm², repair method (i) is not adequate for our laser system.

The repair method (ii) coating has a transmission of 0.10% at 1054 nm and 0.34% at 1064 nm, which is adequate for operation in the laser system, although these values could be improved with better centering of the high reflection band at 1054 nm at the time of LIDT testing. The repair method (ii) coating is actually centered at 1036 nm where transmission is 0.02%, but this was intentional because aging often allows our high reflective coatings of this type to shift 20 nm to higher wavelength. Also, because of the higher transmission at 1064 nm compared with 1054 nm, the LIDT at 1054 nm is likely greater than the 49.0 to 61.0 J/cm^2 values reported here.

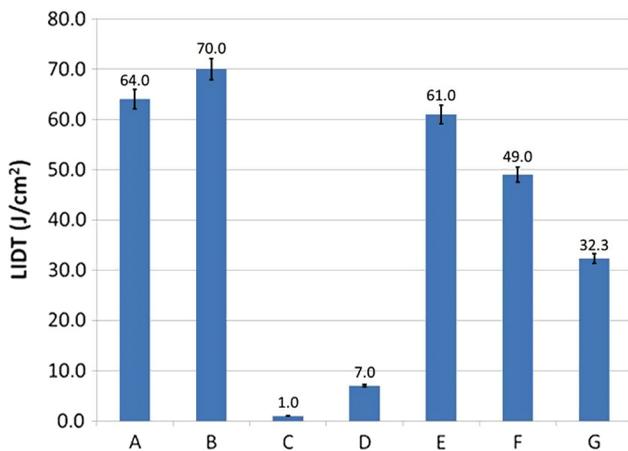
Fig. 6 LIDT measurements of the repaired and unrepaired optical coatings.

deposited as Hf metal. This LIDT, which is dramatically lower than the 64.0 J/cm² LIDT of the correct 42-layer coating, clearly confirms the high susceptibility to laser damage of the Hf metal layer. Our evaluation of each repair method is discussed below in accordance with how close the LIDT of the repaired coating improves to 64.0 J/cm². We also evaluate the optical transmission at the center wavelength of 1054 nm, and the 1064 nm wavelength that was used for LIDT testing. For operation in the laser beam train, the repaired coatings must have a transmission of less than 0.4% at 1054 nm.

As shown in Fig. 6, the LIDT of the repair method (i) coating is just 7.0 J/cm². This repaired coating consists of the incorrect 34-layer coating and a correct 35-layer overcoat. The LIDT of just the 35-layer overcoat is 70.0 J/cm², which indicates that the low LIDT of the repaired coating may still be influenced by the Hf metal layer in the incorrect coating even though that layer is 42 layers deep in the coating. An electric field model of this coating could help us understand whether the deeply buried yet absorbing Hf metal layer may play a large role in reducing the LIDT of the coating. Unfortunately, there was not an adequate amount of refractive index or absorption data available for Hf metal to create an electric field model of this coating in our wavelengths of interest.

An alternative explanation of the poor LIDT of this coating is the possibility of high residual stress. Depositing 35 additional layers on top of an existing 34-layer coating more than doubles the thickness of the original coating and therefore increases its susceptibility to residual stress problems. Furthermore, the original coating was deposited at an earlier time compared with the additional 35 layers, which could lead to a stress mismatch between the original and recoated layers. Fortunately, we did not observe crazing, delamination, or any other obvious physical defects, but these problems could be more apparent on larger optics.

The LIDTs of the repair method (ii) coatings are 61.0 J/cm^2 and 49.0 J/cm^2 , which are adequate for operation in our laser system. The difference between these coatings is that one substrate was located at the center of the planet can (achieving the LIDT of 61.0 J/cm^2), and the other was located 25 cm from the center of the planet can (achieving the LIDT of 49.0 J/cm^2), as explained in Sec. 3. Beyond this difference, the exact causes of the LIDT dissimilarity is not known, and could be due to a number of factors, including coating or etch nonuniformity on the coating plane, which warrant further investigation.

The repair method (iii) coating has an LIDT of 32.3 J/cm^2 . This is a moderate improvement, but still not as satisfactory as the LIDT of the repair method (ii) coating. The LIDT of the repair method (iii) coating suffers because it was discovered that the 24-layer coating that remained on the substrate after the ion milling process was actually a high reflection coating centered at 1085 nm, rather than 1054 nm. We did not know this from the outset because the reflectance of the original incorrect coating was broad, due to the reflective Hf metal layer, as shown in Fig. 5. To maintain consistency among the coating layers, the 10 layers that were recoated to form the 34-layer repaired coating were also centered at 1085 nm. However, because LIDT testing took place at 1064 nm, the transmission of the repaired coating at this wavelength is 0.47%. For comparison, the repair method (ii) coating has a transmission of 0.34% at 1064 nm and achieved an LIDT that was nearly twice as high as the LIDT of the repair method (iii) coating. Moreover, the transmission of the repair method (iii) coating at 1054 nm is 0.71%, which is not adequate for operation in the laser beam train. Consequently, the spectral shift that is an effect of aging of the repair method (iii) coating will further increase the transmission at 1054 nm. It would therefore be interesting to repeat this experiment, starting with a

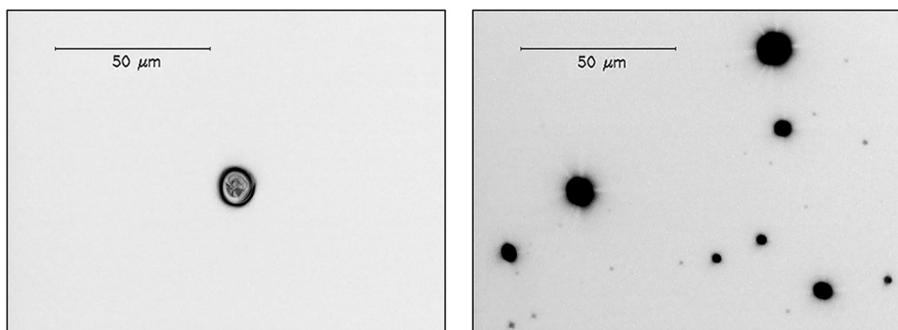
While the repair method (ii) coating meets both the LIDT and spectral requirements for operation in the laser beam train, the presence of pits on the etched substrate is a concern. As mentioned in Sec. 3, small pits were scattered on all etched substrate surfaces, which included the two test substrates and the 65-cm diameter mirror substrate. The pits appeared to be scattered fairly evenly on these substrates, with slightly higher density in the center, and ranged in size from about 5 to $10 \mu\text{m}$, as captured by the microscope images in Fig. 7. A visual inspection revealed the density of pits to be $\sim 40 \text{ pits/cm}^2$ in the worst case at the center of the substrate.

Optical scattering is a problem associated with pits, but the effect has been negligible since the repaired mirror has been operating in the beam train since April 2014. In other words, the performance of the laser system did not change after the repaired mirror was introduced as a replacement for the original mirror. We suspect that high reflection coatings are more resilient in terms of their ability to perform well on an inferior substrate because only a small fraction of light actually transmits through to the substrate before being reflected back to the incident medium. Also, the relatively

Fig. 7 Microscope images of the 5 to $10 \mu\text{m}$ pits that were scattered on the repair method (ii) substrates.

large thickness of high reflection coatings may be better able to fill in defects on a substrate surface. On the other hand, the high density of substrate pits could be very harmful to the LIDT of transmissive coatings due to absorption at these defect sites, causing coating damage or removal. However, at a later time we used the same ion milling process to remove an 8-layer coating from a lens (1132-nm thick coating, versus 7758-nm thick for the 42-layer coating in this study) and observed that the density of pits was much lower: ~ 1 to $5/\text{cm}^2$. The presence of these imperfections on the lens is not ideal, but certainly more suitable for a transmissive coating compared with the mirror substrate analyzed in this study. Ultimately, our experiments demonstrate that etch time has a direct effect on the density of substrate pits. Future research could involve tuning the ion milling process to reduce pitting, perhaps by decreasing the ion energy once the substrate surface becomes visible, though this will increase the time to etch away the remainder of the coating.
