# Failure analysis and improvement of tact switch in smart meter after accelerated life testing (ALT)

Yong Huang\*, Xin Jin, Tianyu Liu, Weixin Sun, Min Zhang, Xingdong Jing  
State Grid Tianfu New Area Electric Power Supply Company, Chengdu 610213, Sichuan, China

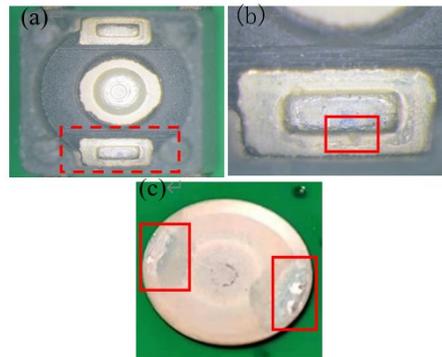
Disassemble the failed switch 1<sup>#</sup>. Figure 3 is the photo of the internal terminal and reed of the failed switch. Figure 3a is the top view of the brass terminal, the core component of the switch. White deposits are found near one of its contact surfaces, as shown in Figure 3b. Figure 3c is a photograph of the concave surface of the reed, and it was found that there are also white deposits near the contact positions between the concave surface and the two ends of the copper terminal and in the center. After the foreign matter was removed, the function of the switch returned to normal, and it was speculated that the white deposit might be the cause of the poor contact of the switch.

Figure 3. Reed and terminal photos of 1<sup>#</sup> failed switch.

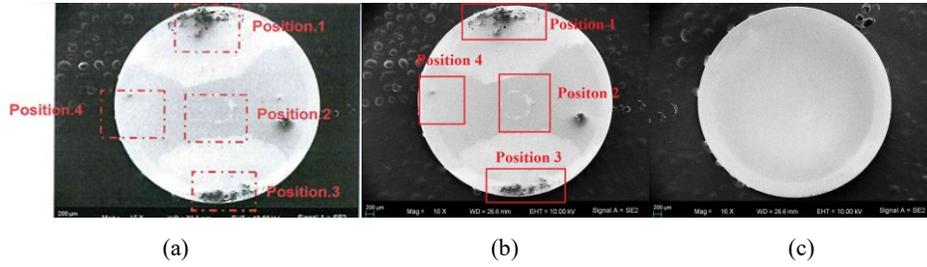
In order to further analyze the composition of the white deposit, the failed switch (2<sup>#</sup> and 3<sup>#</sup>) and the new sample (4<sup>#</sup>) without reliability test were sent to the third-party reliability research and analysis center for analysis by AUPRA 55VP scanning electron microscope. As shown in Figure 4, it was observed under the scanning electron microscope that there was foreign matter near the contact positions (positions 1 and 3) between the reed and the terminal of the failed samples 2<sup>#</sup> and 3<sup>#</sup>, and there was also a small amount of unknown foreign matter near the center (position 2). The surface of sample 4<sup>#</sup> was smooth and free of foreign matter. As shown in Figures 4-6, for samples 2<sup>#</sup> and 3<sup>#</sup>, position 1, position 2, position 3 with foreign matter and position 4 without foreign matter were selected for component analysis, and the central position was selected for sample 4<sup>#</sup> when component analysis.

Figure 4. Photo of the surface morphology of the spring. (a) 2<sup>#</sup>; (b) 3<sup>#</sup>; (c) 4<sup>#</sup>.

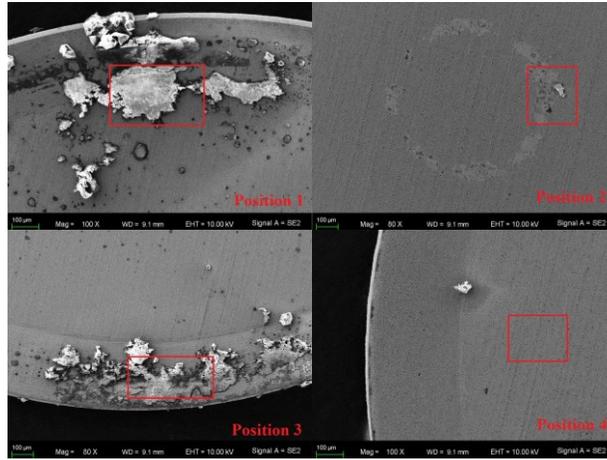
Figure 5. Surface morphology photos and 4 EDS testing positions on sample 3<sup>#</sup>.

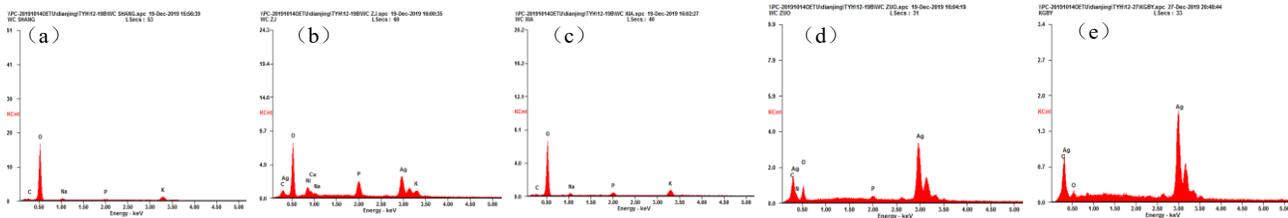
Figure 6. X-ray energy spectrum of switch spring (a) Position 1 of 3<sup>#</sup>; (b) Position 2 of 3<sup>#</sup>; (c) Position 3 of 3<sup>#</sup>; (d) Position 4 of 3<sup>#</sup>; (e) Sample 4<sup>#</sup>.

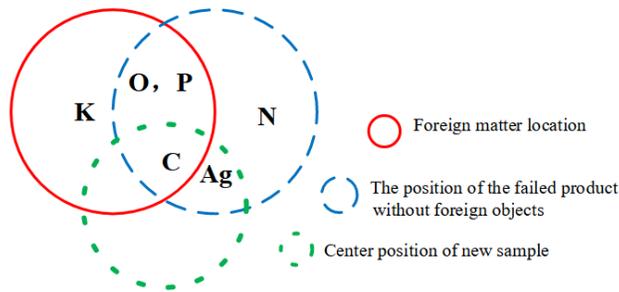
Analyzing the test data in Table 2, as shown in Figure 7, the marked elements in the red solid coil represent the common elements detected at the 6 foreign matter positions of the failed switch, the marked elements in the blue short coil represent the elements detected at the 2 non-foreign matter positions of the failed switch, and the marked elements in the green dotted coil represent the elements detected at the new switch. It was found that element C was the common element tested in six foreign matter positions, two non-foreign matter positions of the defective product and the new switch. 3<sup>#</sup> Failure sample position 1 and position 3 did not detect the Ag element on the concave surface of the reed because the surface foreign matter has completely blocked the surface of the Ag layer below. Ag element was detected in both the foreign matter free positions of the two failed samples and the new switch. The O and P elements were detected at the 6 foreign matter positions and the non-foreign matter positions of the 2 failed switches. The K element was the only element that was detected at the 6 foreign matter positions but not at the non-foreign matter positions of the new samples and the failed switches, and the content of O element at the 6 foreign matter positions increased, so it was speculated that the white foreign matter might be potassium salt.

Figure 7. Schematic diagram of EDS result analysis.

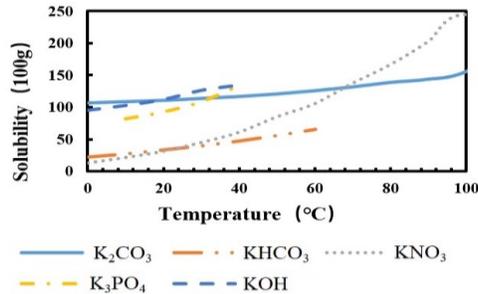
As shown in Figure 9, the solubility of several common potassium salts in water increases with the increase of temperature. With the rapid cooling and dehumidification after each cycle of the ALT experiment, the solubility of

potassium salt decreases and the solvent decreases, causing potassium salt to precipitate and adhere to both ends of the reed. Due to the poor conductivity of solid potassium salts, the switch fails to conduction.

Figure 9. Solubility curves of common potassium salts in water.
