Repair of a mirror coating on a large optic for high laser damage applications using ion milling and over-coating methods

Ella S. Field
John C. Bellum
Damon E. Kletecka

Sandia National Laboratories, PO Box 5800, MS 1191, Albuquerque, New Mexico 87185, United States

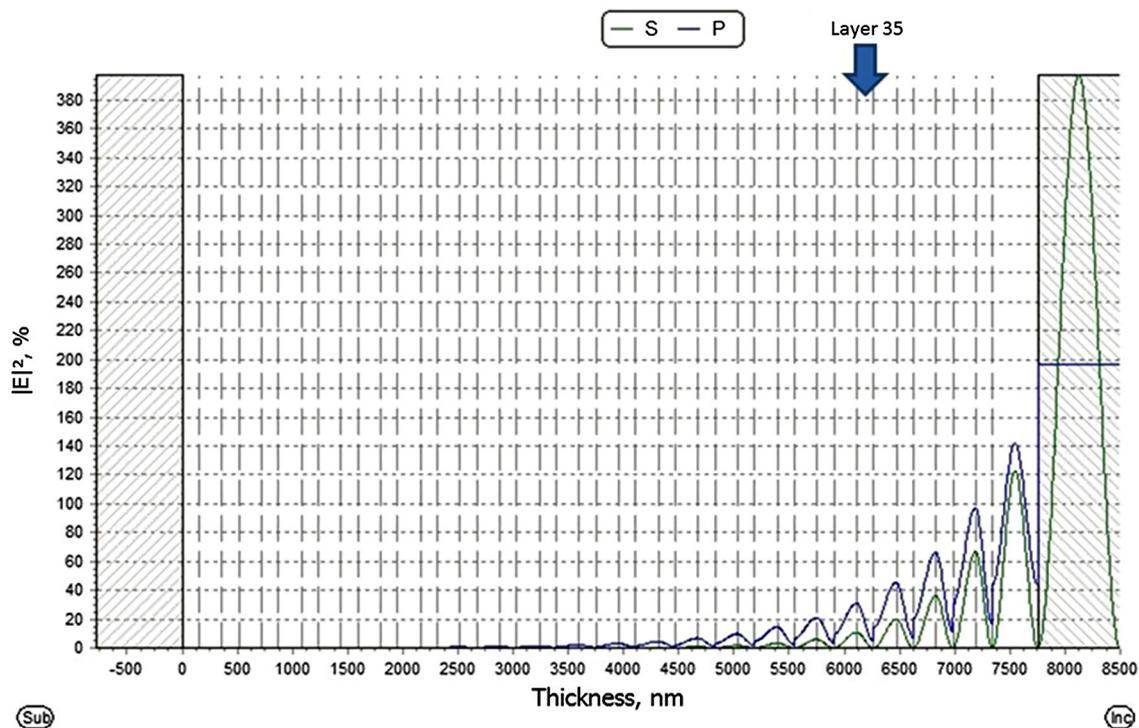
The electric field magnitude in a high reflection coating quenches rapidly within the outermost coating layers, as shown in Fig. 1, which is an electric field model generated by OptiLayer software of the 42-layer quarter wave design. The reasoning behind repair method (i) is that the deposition of a correct mirror coating on top of an incorrect mirror coating would even further diminish the amount of light penetrating into the incorrect coating. Therefore, the incorrect coating may be prevented from greatly impacting the LIDT. This repair method is therefore most suitable for mirror coatings rather than high transmission coatings. The primary advantage of over-coating is that it is straightforward and faster than the ion milling approaches that we also tested. A disadvantage of this method concerns the possibility of delamination and crazing as a result of stress mismatch between the incorrect coating and the correct over-coating.

Fig. 1 Electric field magnitude model of the 42-layer $\text{HfO}_2/\text{SiO}_2$ quarter-wave type coating design, shown at 1054 nm, 45 deg in P-pol and S-pol. The vertical dashed lines denote layer boundaries. When this coating was deposited, a lack of oxygen resulted in the deposition of Hf metal instead of HfO_2 for layer 35. At the boundaries of layer 35, the electric field intensity, as a fraction of the incident intensity, is 30% at the start of the layer and 15% at the end of the layer.

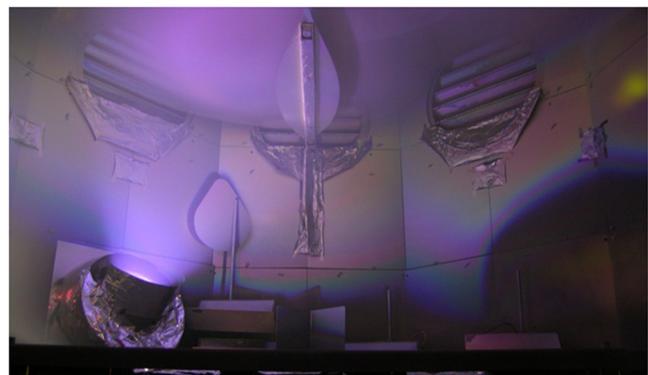
We performed ion milling using our 16-cm diameter RF ion source (manufactured by Veeco), which is normally used for ion-assisted deposition. As shown in Fig. 2, the ion beam is oriented diagonally to aim at the center of the rotating planet can when it is located on the opposite side of the chamber. We performed a preliminary ion milling test on a slab of float glass that was 94-cm diameter truncated to 44-cm wide in order to test different ion milling parameters and establish the settings to use for etching the large 65-cm diameter optic. The slab of float glass was prepared with the 34-layer test coating having the intentional Hf metal layer located at layer 27. We etched the float glass until layer 25 was removed. Several lessons were learned as a result of this initial ion milling test with float glass, which are summarized in the points later.

Fig. 2 The RF ion source.
