# Failure analysis and improvement of tact switch in smart meter after accelerated life testing (ALT)

Yong Huang\*, Xin Jin, Tianyu Liu, Weixin Sun, Min Zhang, Xingdong Jing  
State Grid Tianfu New Area Electric Power Supply Company, Chengdu 610213, Sichuan, China

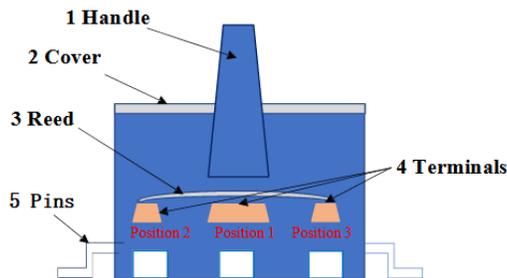
Figure 2. Schematic diagram of the internal structure of the switch.

Figure 2 is a schematic diagram of the internal structure of the switch. wherein the part 1 is a handle of the switch, which is made of a plastic material FR52, and the part 2 is a cover plate, which is commonly made of stainless steel or plastic materials. Part 3 and part 4 are the core parts of the tact switch. Part 3 is called the reed, which is shaped like a pot cover, concave downward, made of stainless steel, silver-plated on the surface, and also known as the pot piece in the industry. The part 4 is a terminal made of brass with a surface treatment of Ni plating and then silver plating. Part 5 are the pins of the switch. The internal terminal has three contact points, position 2 and position 3 are in contact with the reed. When the handle bounces up, position 1 is disconnected from the reed, and the switch is in the disconnected state. When the handle is pressed down, the reed is in contact with position 1, and the switch is connected<sup>8</sup>. In this article, the performance of the failure switch is when the handle bounces up, the switch is in the open state, and when the handle is pressed down, the switch is still unable to conduct.
